Weld mesh used to protect a refurbished bridge in London

Location: Southwark, London
Structure: Bridge

Problem: Pigeon Proofing
Solution: Weld Mesh Sheeting & Bird Free Gel

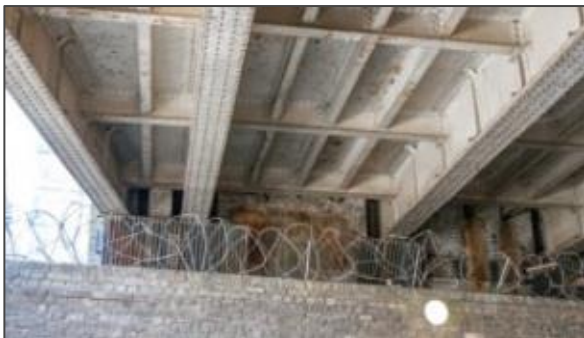
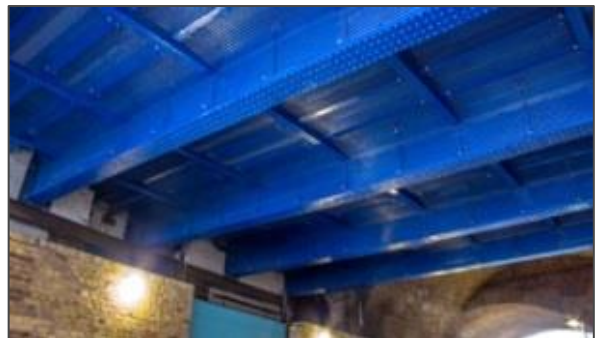
Our bird proofing solution was based upon weld mesh sheeting being installed to prevent the birds gaining access to the underside of the bridges and beams. Weld mesh is fast becoming the standard media for bird proofing bridges and other public structures where traditional nylon netting has been used before and damaged, allowing pigeons to re-enter and become trapped, causing the unnecessary death of the pigeon, distress to the public and action by pigeon protection groups.

As the bridges are old, most of the structure has been modified or changed in some way, so each sheet is measured and cut to fit exactly in the gaps. Clamps were used to ensure the mesh, once positioned, would be permanent, with the threads locked using thread adhesive to prevent shaking and vibrations working them loose.

Further vibration protection was added under the weld mesh and fixings to complete the solution.
